Mounting/Demounting Instructions UHP* and Run Flat Tyres**

Attachment 2 Summary of criteria

Tyre characteristics

- Examples of criteria to judge on improper mounting or demounting
- Evaluation
- Consequences
- Preventive measures

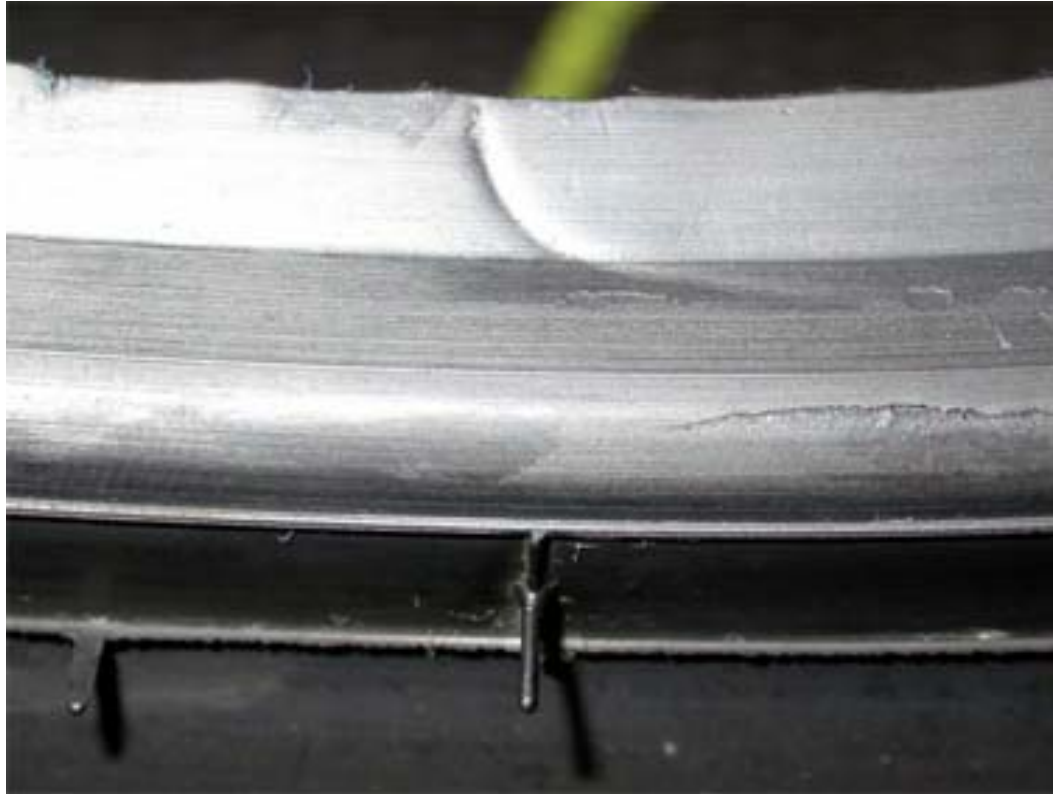
Characteristic:

impression of rim flange at point of traction

Cause:

excessive tension during mounting procedure

Consequence:

check tyre for leaks

Preventive measures:

use suitable tyre changer and tools;
apply sufficient lubricant in line with mounting instructions

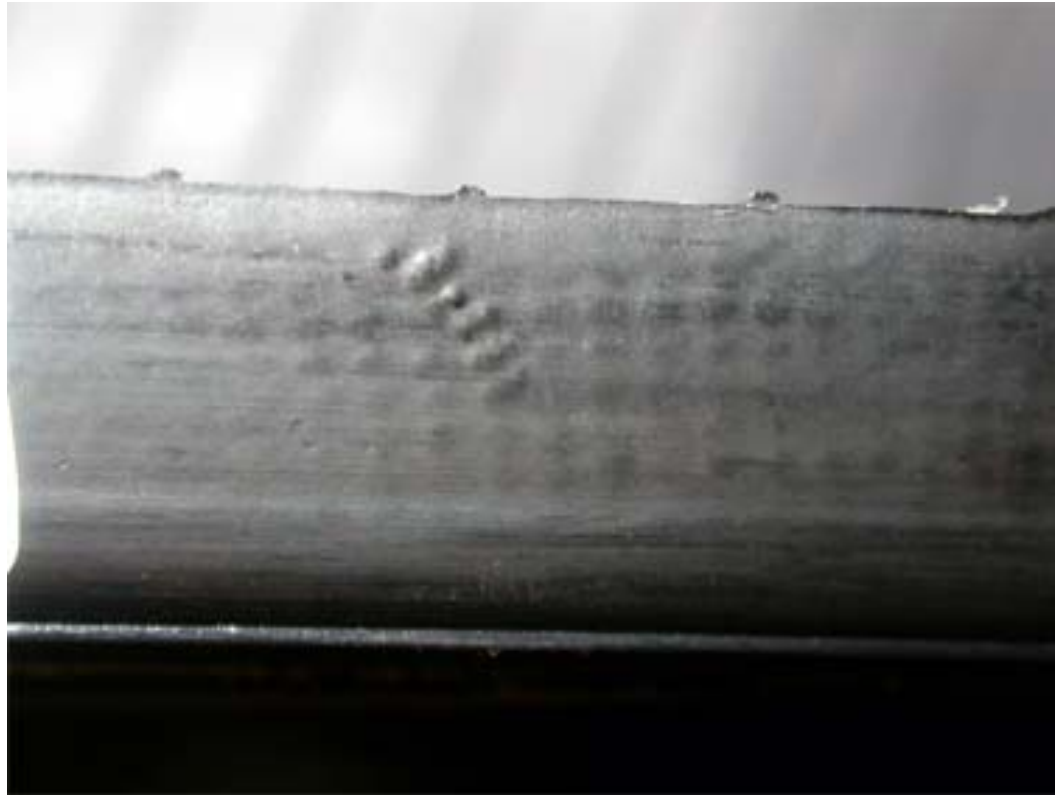
Characteristic : overstretching of bead base at point of traction

Cause: excessive tension during mounting procedure

Consequence: check tyre for leaks

Preventive measures: use suitable tyre changer and tools; apply sufficient lubricant in line with mounting instructions

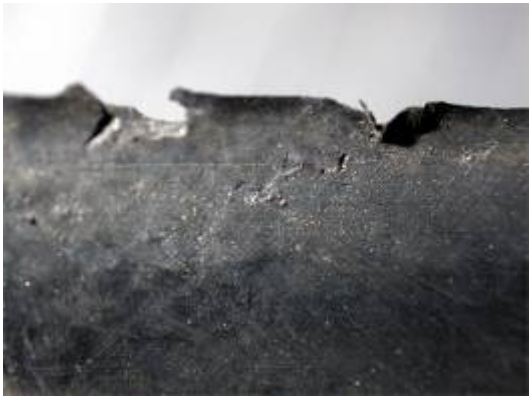
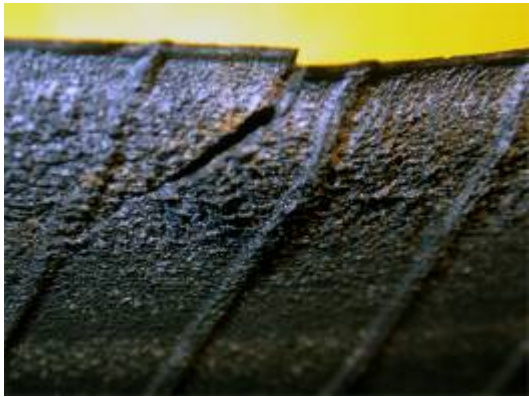
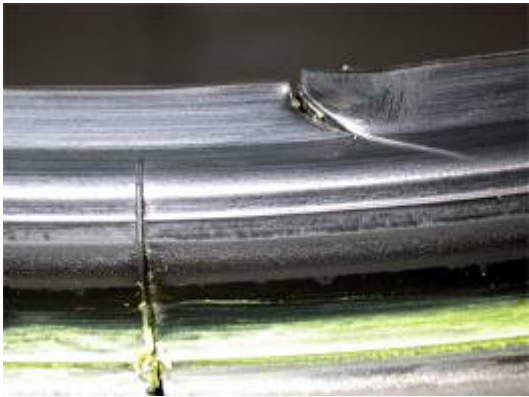
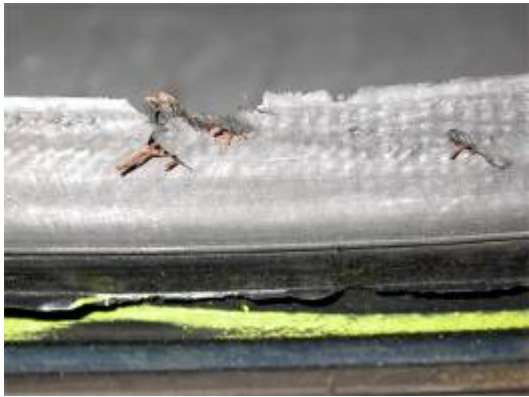
Characteristic : bead toe slightly ripped

Cause: sharp-edged mounting head, sharp-edged rim flange

Consequence: if minor scratches are found in the rubber, tyre can be used again; if scratches reach as far as to the ply: discard tyre

Preventive measures: check / replace mounting head; add rim flange protection; use bead clamp, apply sufficient lubricant

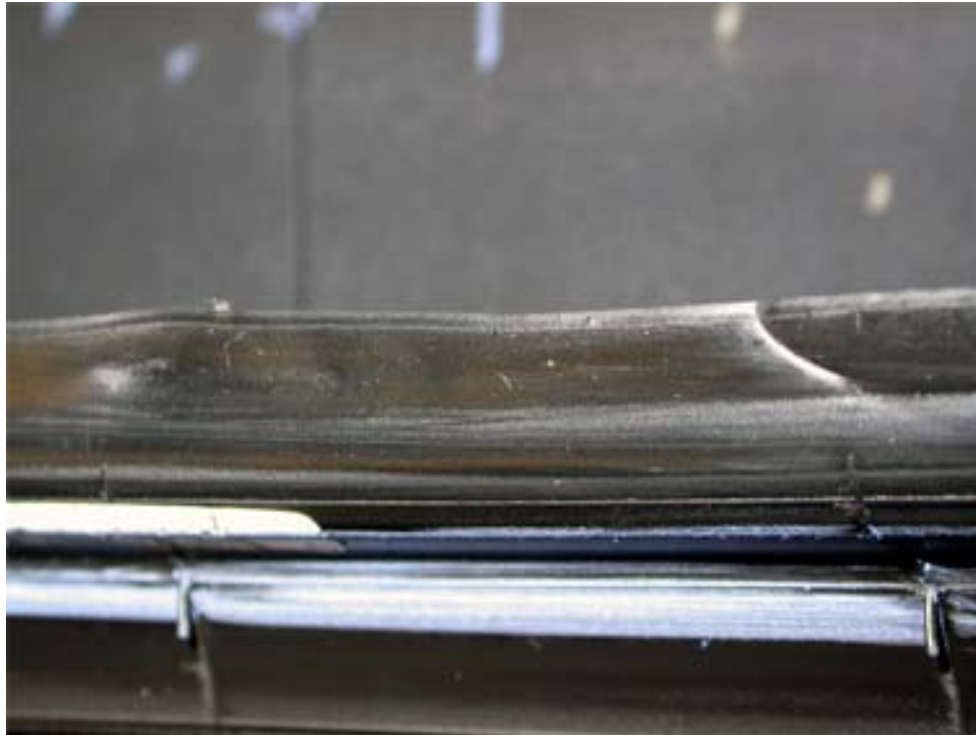
Characteristic : bead base deformed at point of traction

Cause: unsuitable bead clamps, not properly applied;
tyre and bead clamps slip off

Consequence: check inner liner for damage (also see inner liner damages);
check tyre for leaks

Preventive measures: correctly apply suitable bead clamp; avoid slipping off

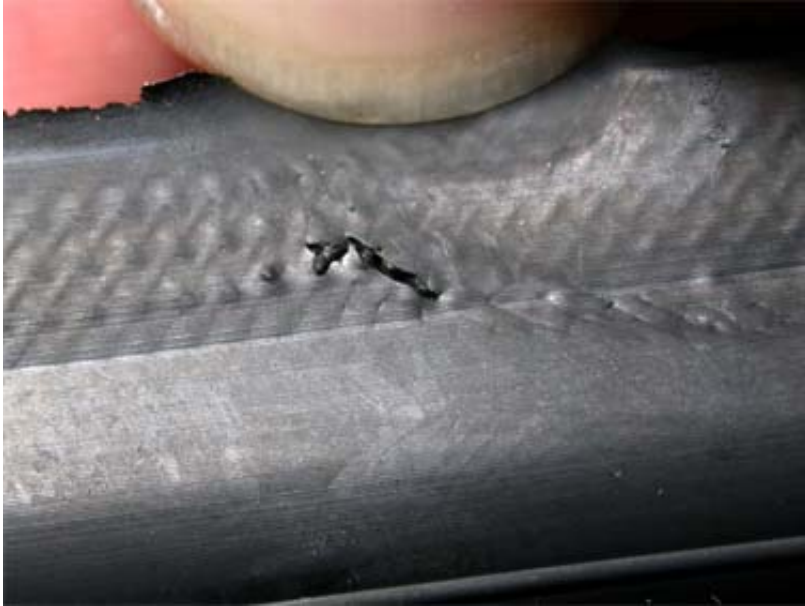
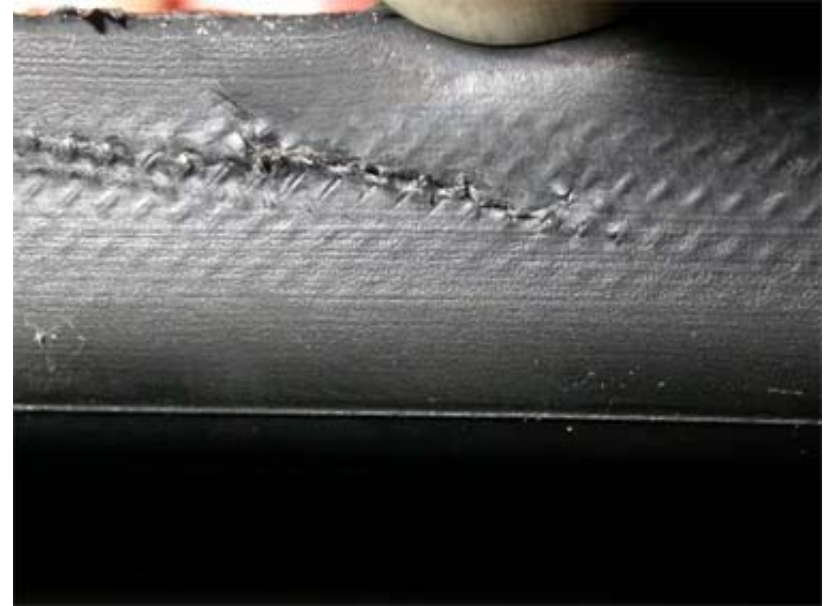
Characteristic : bead base damaged as far as to the ply

Cause: high tension at point of traction during mounting procedure

Consequence: discard tyre

Preventive measures: apply sufficient lubricant; add rim flange protection;
use bead clamp

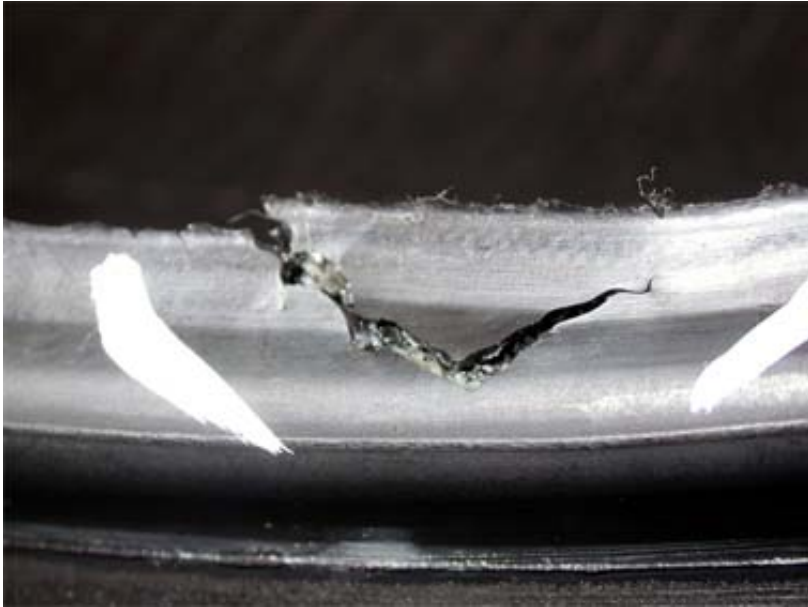
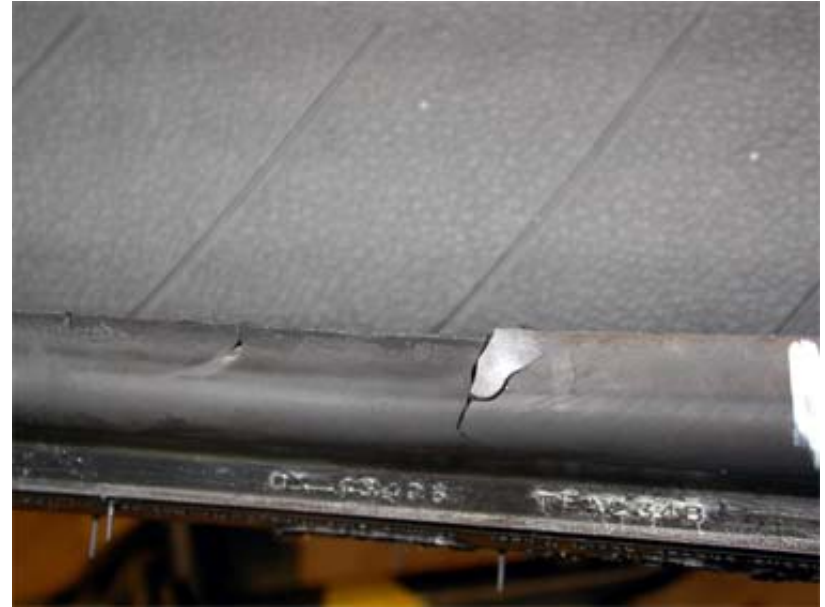
Characteristic : bead toe and bead base damaged

Cause: excessive tension during mounting procedure caused bead to slip off the mounting head

Consequence: discard tyre

Preventive measures: position mounting head properly; make sure core temperature does not fall below 15 °C minutes!

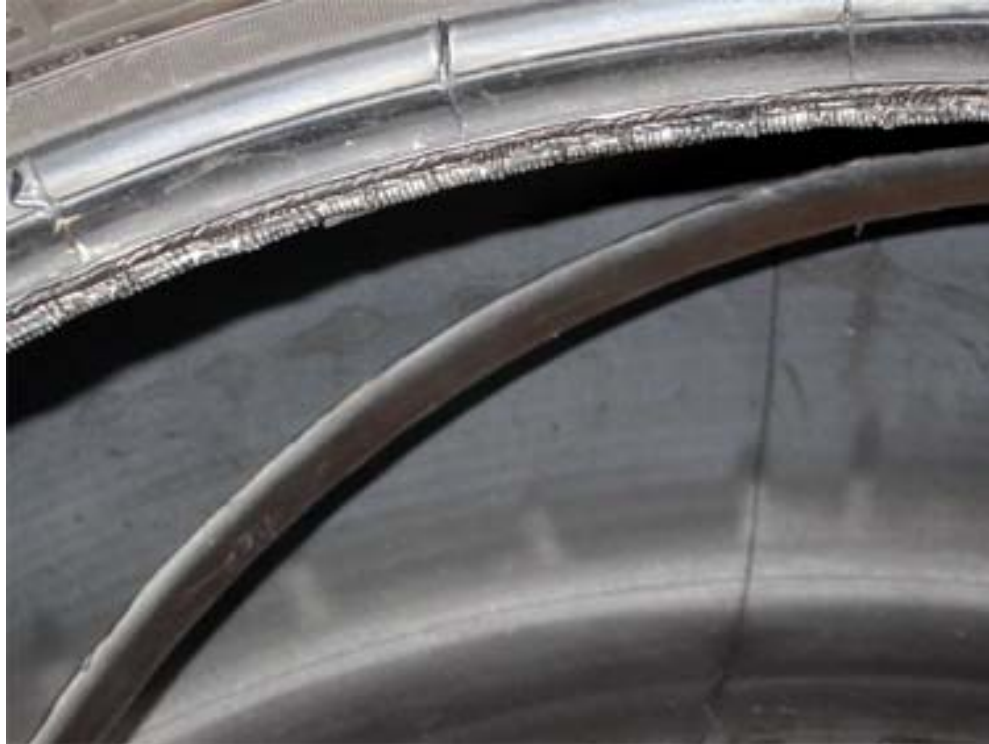
Characteristic : bead base torn off during demounting procedure

Cause: bead already slightly damaged during mounting procedure

Consequence: discard tyre

Preventive measures: use suitable tyre changer and sufficient lubricant

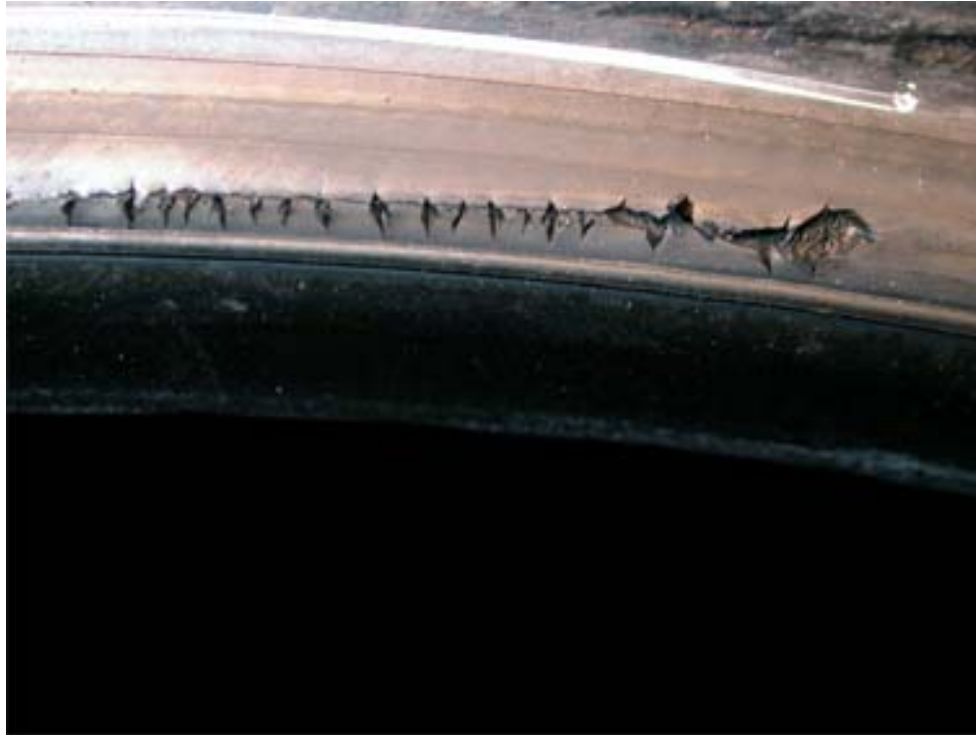
Characteristic : bead heel damaged

Cause: excessive friction at mounting head

Consequence: discard tyre

Preventive measures: use suitable bead clamp or hold-down device to avoid high tension; make sure bead is properly seated on mounting head; apply sufficient lubricant

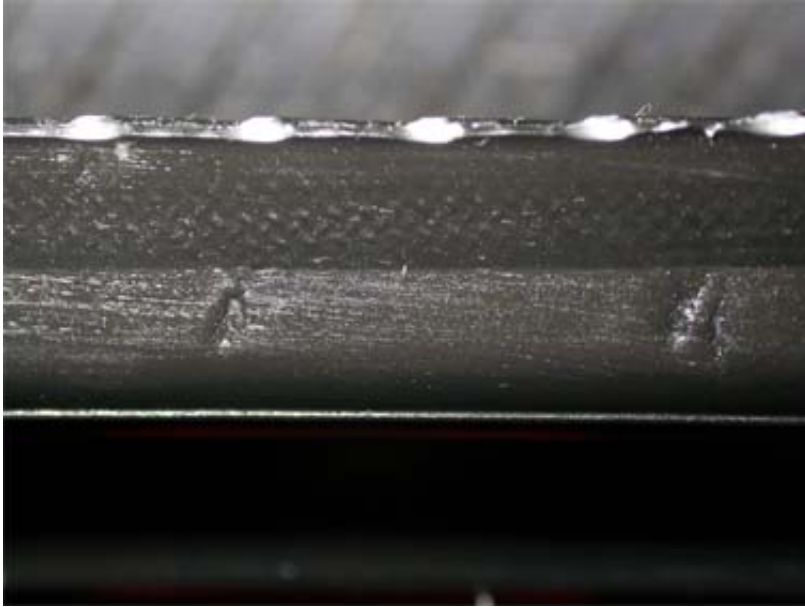
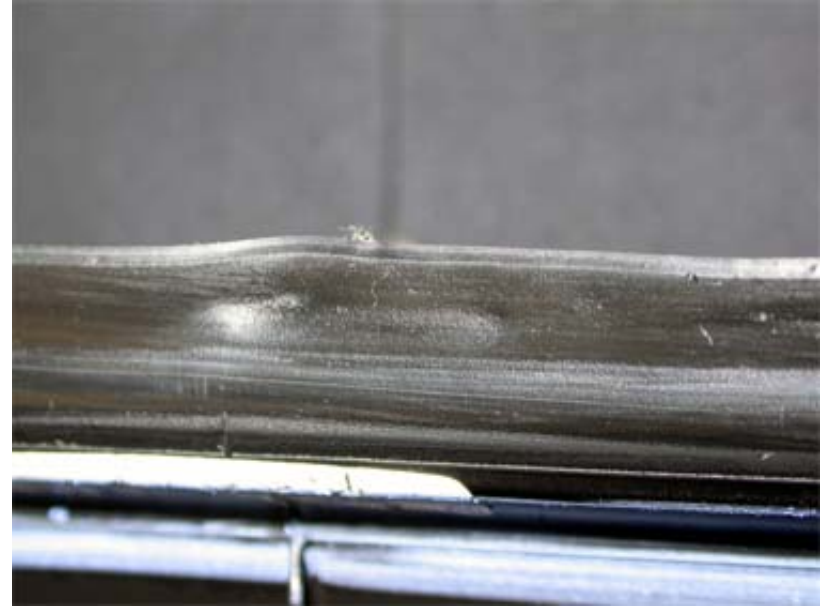
Characteristic : impression of tyre tool in bead base / bead heel

Cause: tyre bead was levered over mounting head with unsuitable tyre lever and using excessive forces

Consequence: check tyre for leaks

Preventive measures: use suitable tyre lever; lever bead over slowly and without tensioning; apply sufficient lubricant

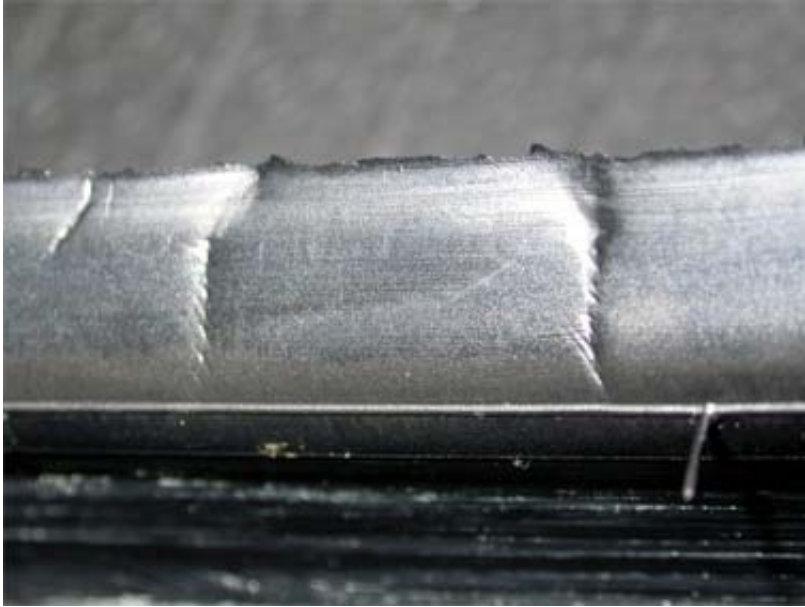
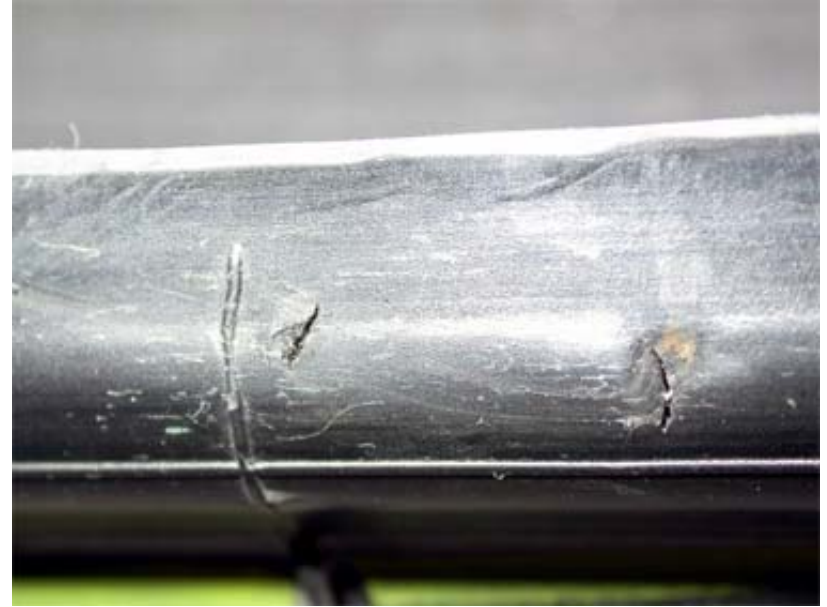
Characteristic : impression of tyre tool in bead base / bead heel, rips

Cause: tyre bead was levered over mounting head with unsuitable tyre lever and using excessive forces

Consequence: discard tyre

Preventive measures: use suitable tyre lever; lever bead over slowly and without tensioning; apply sufficient lubricant

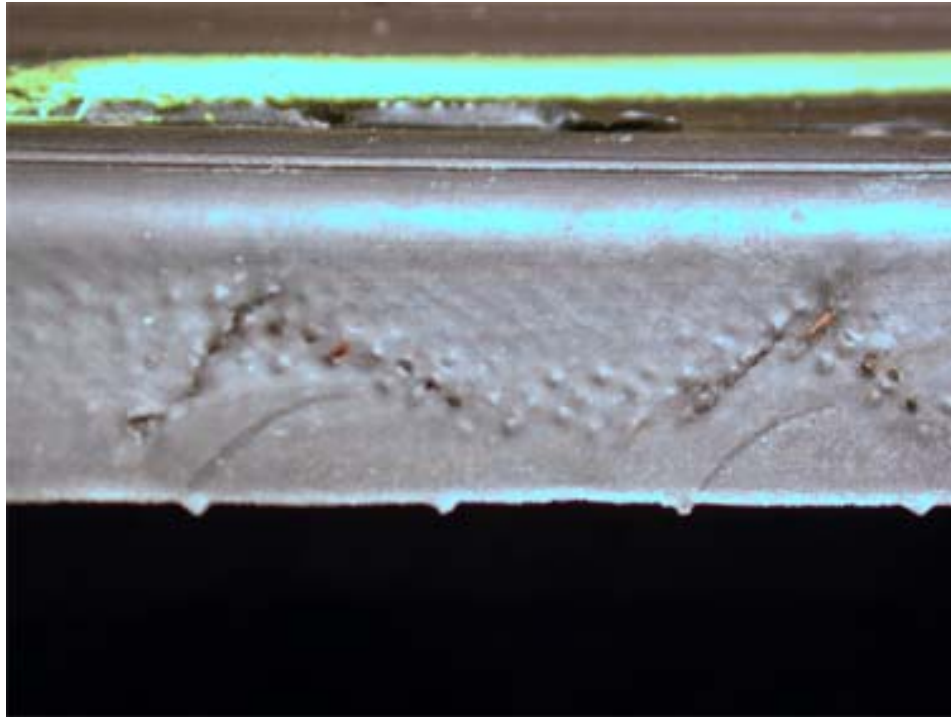
Characteristic : impression of tyre tool in bead base / bead heel
so that even ply is ripped

Cause: tyre bead was levered over mounting head with unsuitable tyre
lever and using excessive forces

Consequence: discard tyre

Preventive measures: use suitable tyre lever; lever bead over slowly and without
tensioning; apply sufficient lubricant

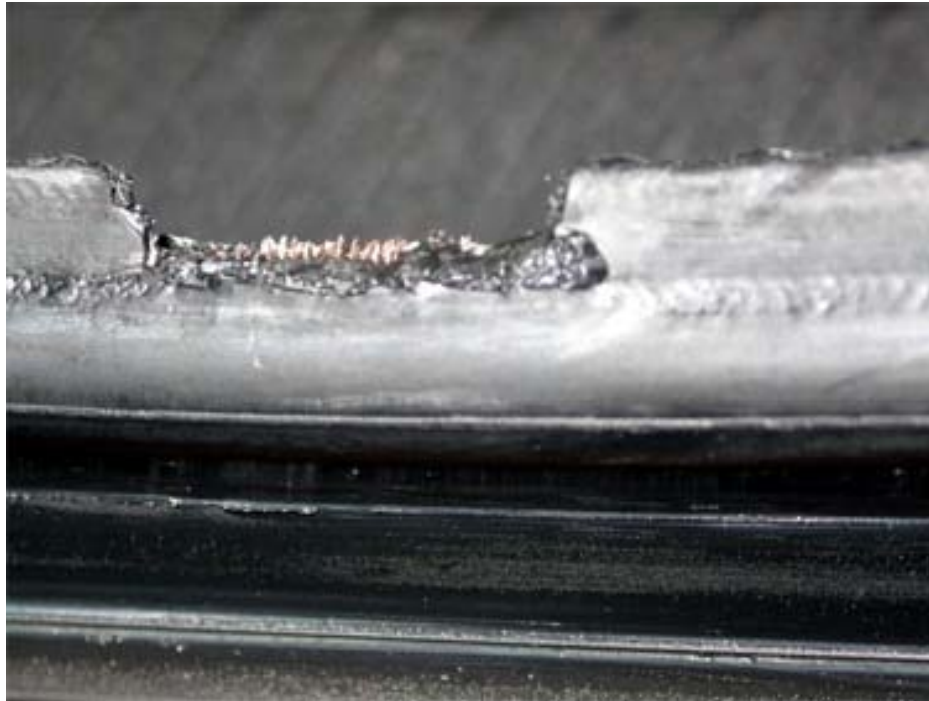
Characteristic : bead toe torn off

Cause: sharp-edged mounting head not properly positioned; mounting procedure not stopped at once; excessive tension

Consequence: discard tyre

Preventive measures: use suitable bead clamp, position mounting head properly; avoid tension, stop mounting procedure at once when mounting head slips off

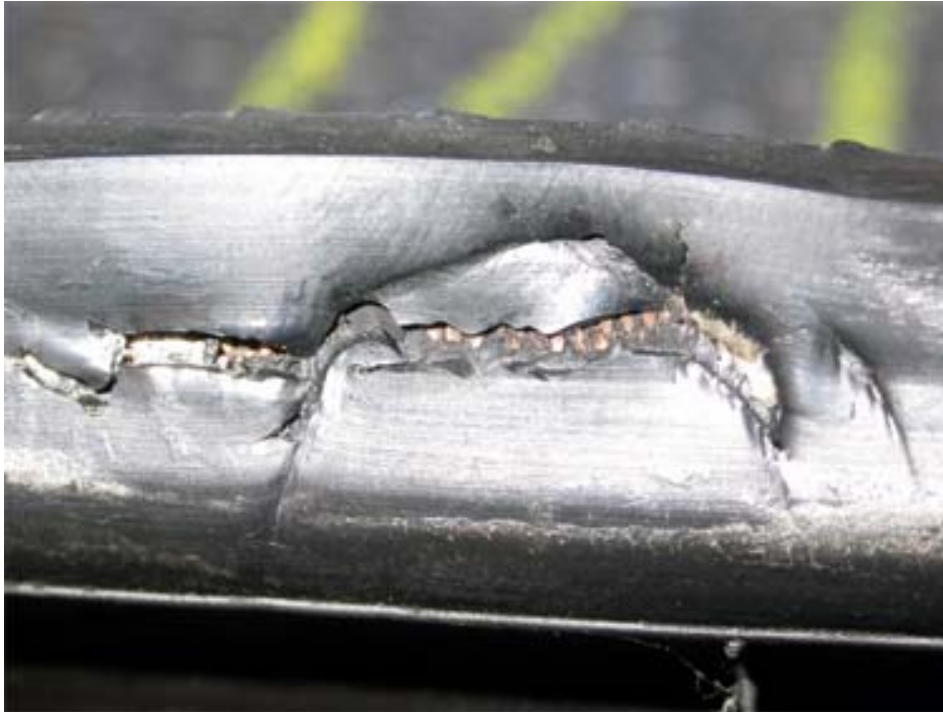
Characteristic : bead rubber layer separated as far as to the ply

Cause: tyre lever not inserted as far as necessary and bead rubber layer damaged with tyre lever tip

Consequence: discard tyre

Preventive measures: use suitable tyre lever and suitable bead clamps, insert tyre lever far enough without using excessive forces

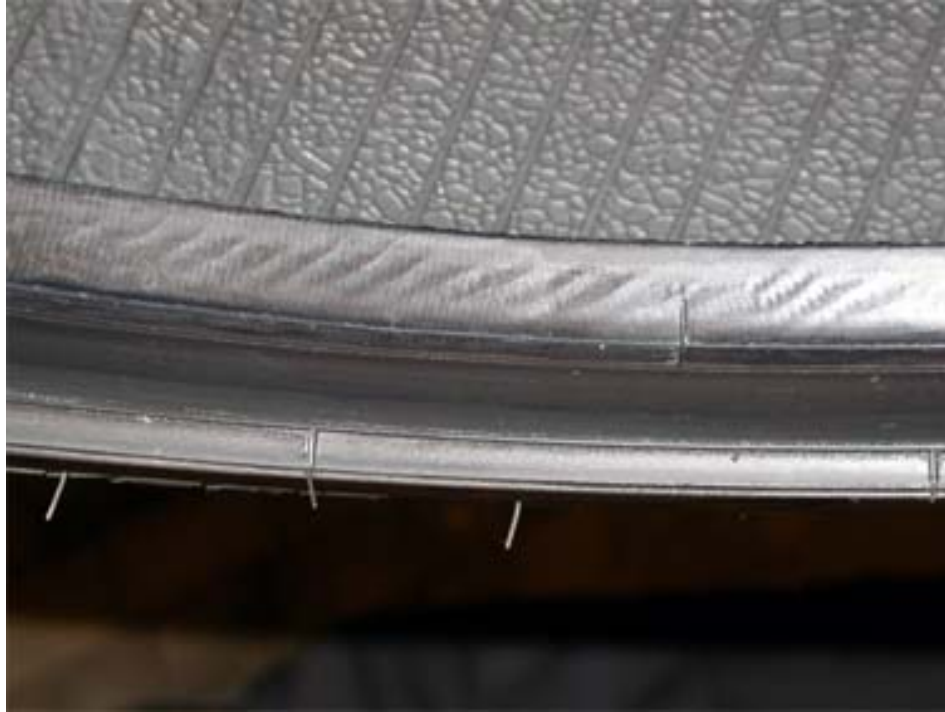
Characteristic : bead cover layer distorted during demounting procedure

Cause: excessive tension on bead circumference during demounting procedure

Consequence: check tyre for leaks

Preventive measures: demount slowly and lubricate sufficiently

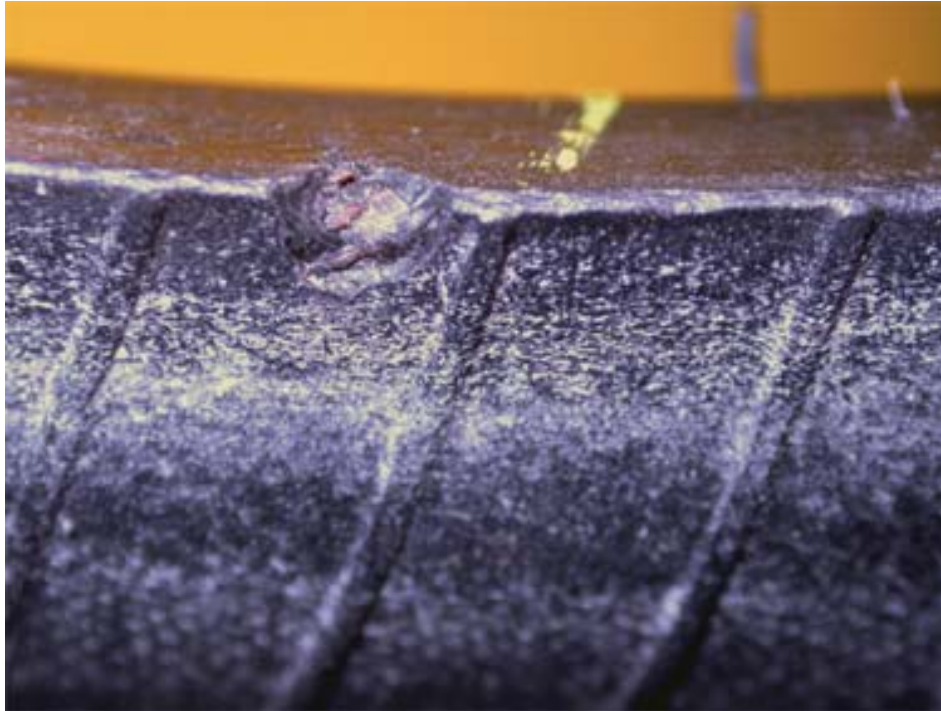
Characteristic : bead toe cut at point of traction

Cause: excessive tension, sharp-edged rim flange

Consequence: discard tyre when cut reaches as far as to the ply

Preventive measures: apply sufficient lubricant; add rim flange protection; use bead clamp

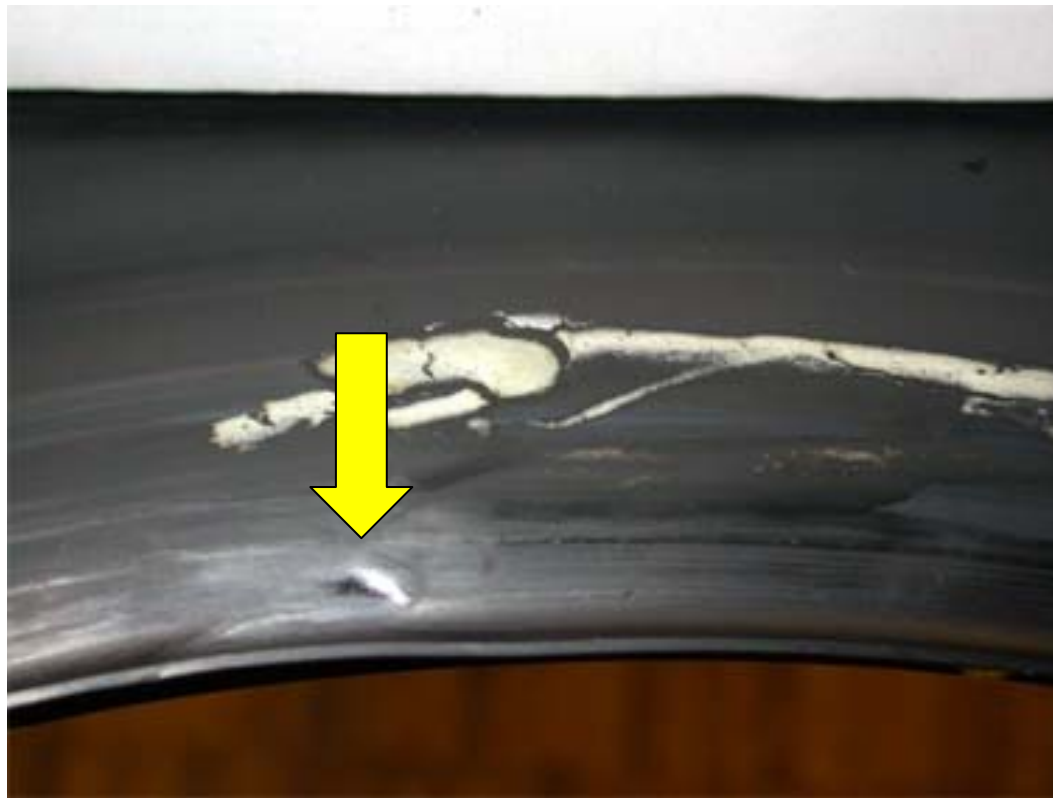
Characteristic : impression in inner liner over bead toe

Cause: high tension at point of traction, caused by sharp-edged rim flange

Consequence: discard tyre when inner liner is torn

Preventive measures: mount tyre without tensioning; use rim flange protection in case of sharp-edged rim flanges; apply sufficient lubricant on inner liner

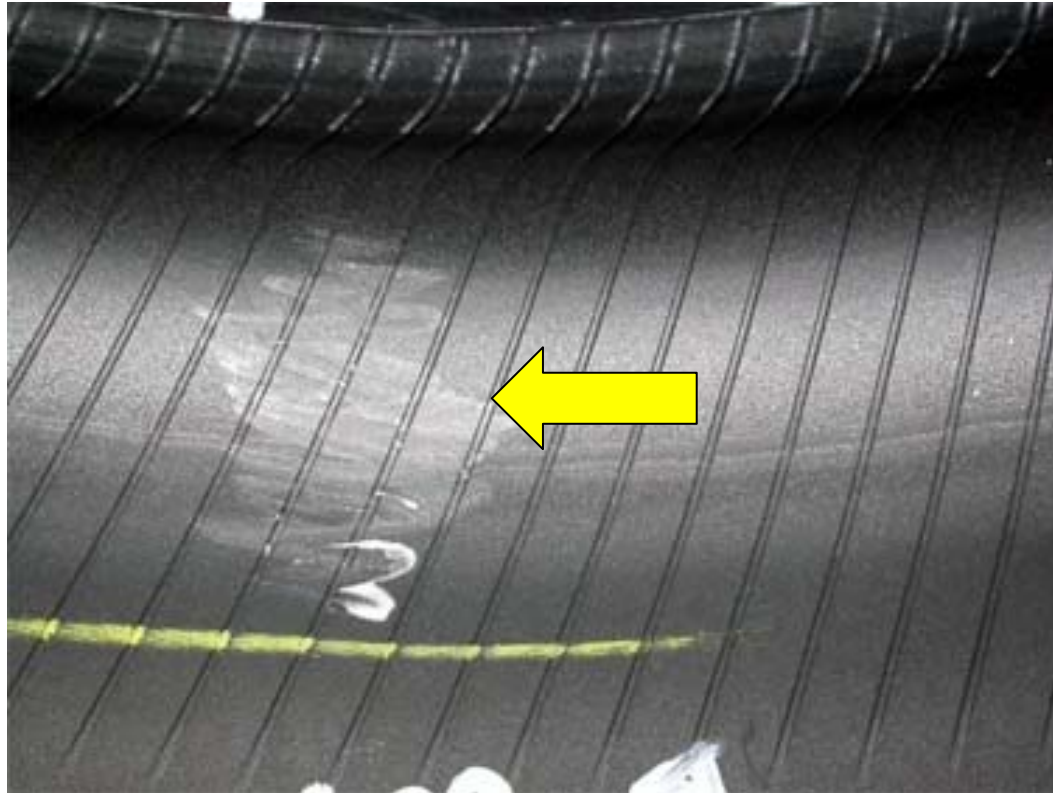
Characteristic : inner liner scratched by tyre lever

Cause: tyre lever inserted too much during demounting procedure

Consequence: discard tyre when inner liner is torn

Preventive measures: use suitable tyre lever; do not insert too much during demounting procedure

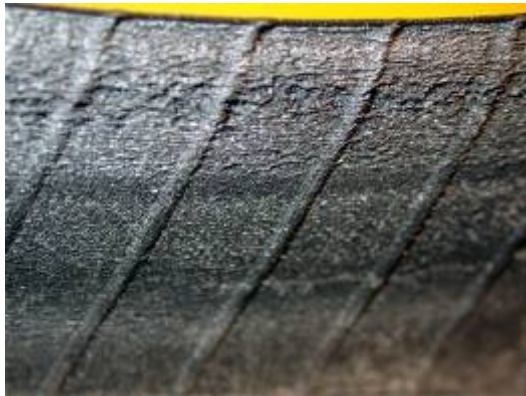
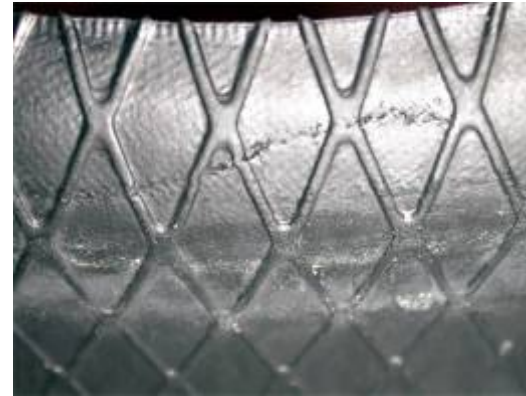
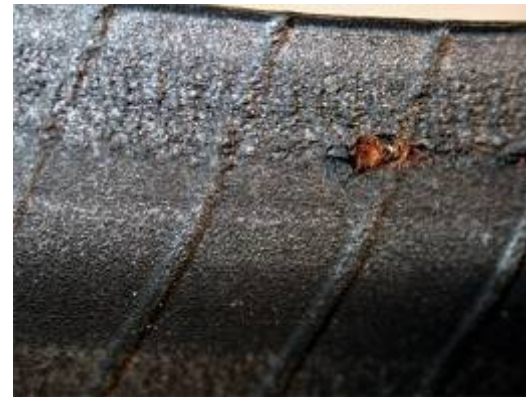
Characteristic : inner liner scratched / slightly ripped below bead toe

Cause: sharp-edged mounting head, excessive tension,
not sufficient lubricant

Consequence: discard tyre when inner liner is torn

Preventive measures: use sufficient lubricant; check mounting head for sharp edges and replace, if necessary

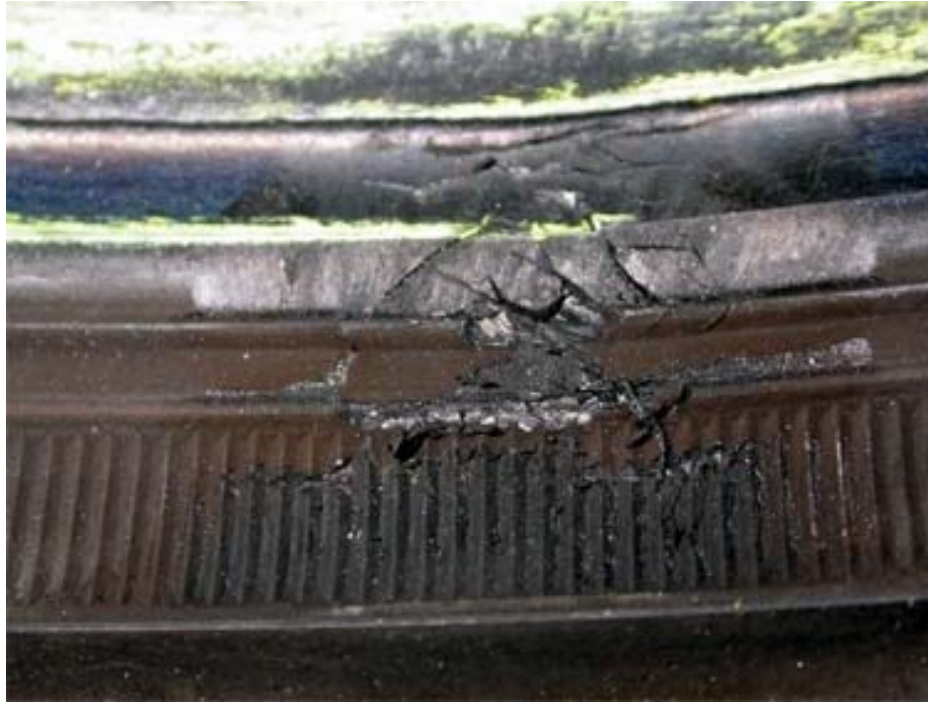
Characteristic : bead heel and mounting guide rib damaged

Cause: sharp-edged tyre lever forcibly inserted during demounting procedure

Consequence: check tyre for leaks; when damaged as far as to the ply, discard tyre

Preventive measures: use round tyre lever using less forces and apply sufficient lubricant

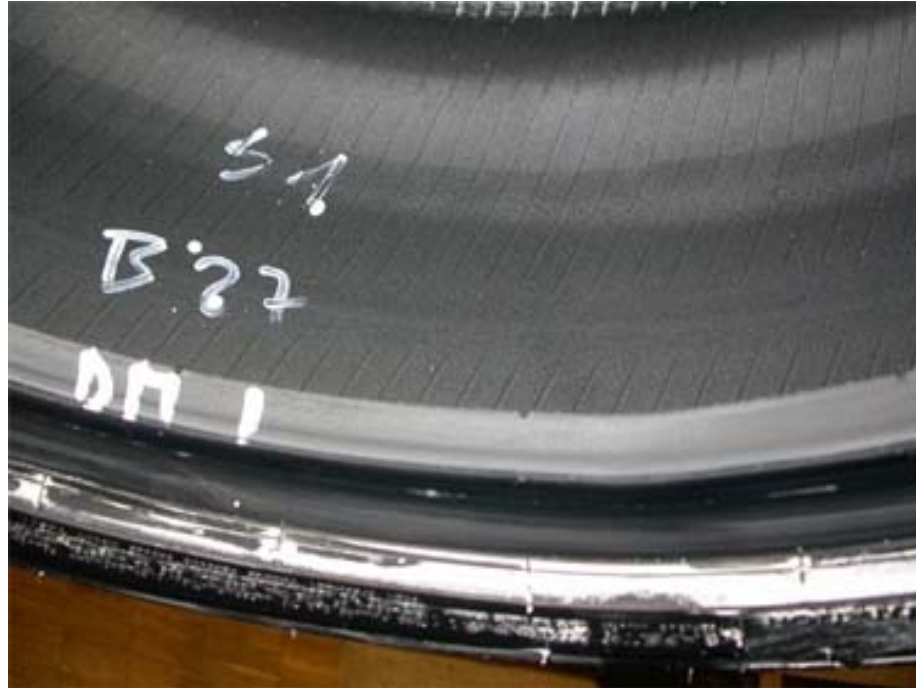
Characteristic : bead and core are deformed

Cause: mounting head of tyre changer went too far,
producing excessive tension

Consequence: check inner liner for damage and bead for broken core

Preventive measures: move mounting head to correct position; avoid tension
caused by raising mounting head too much; apply lubricant
on bead and inner liner

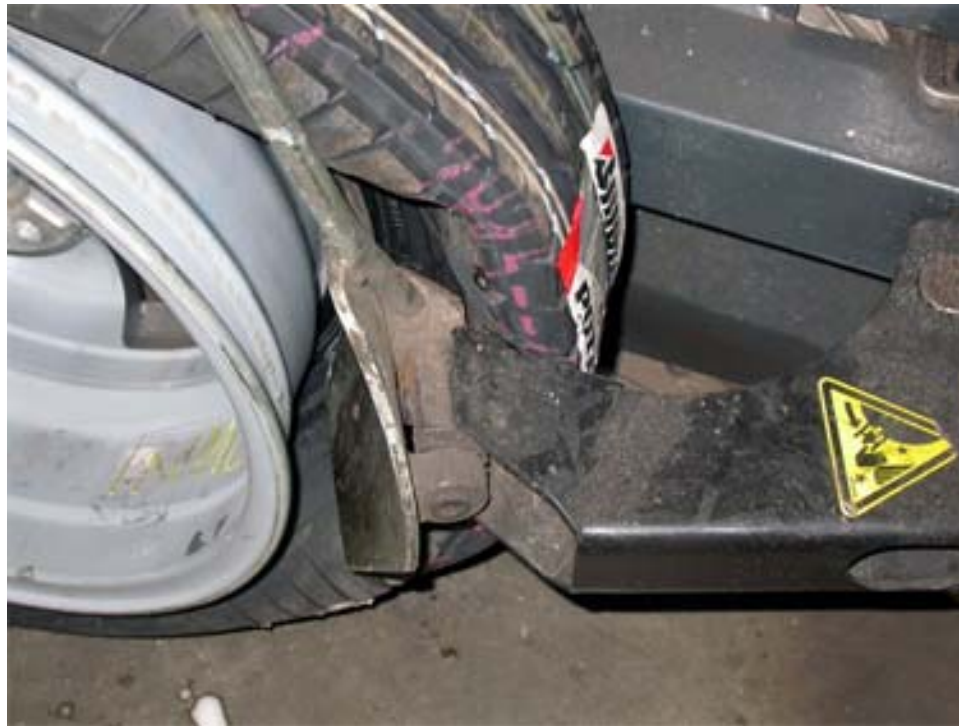
Characteristic : bead deformed, side-wall and belt edges bent

Cause: bead breaker blade forcibly applied at fully depth

Consequence: discard tyre for risk of long-term damage caused by separation in tyre structure

Preventive measures: use bead breaker with limited stroke

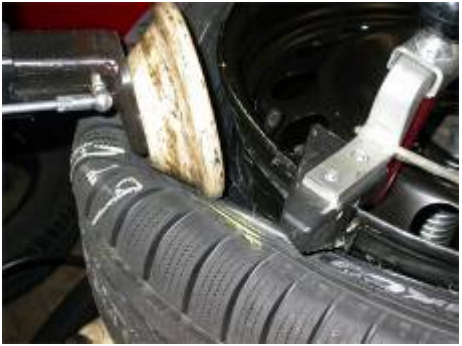
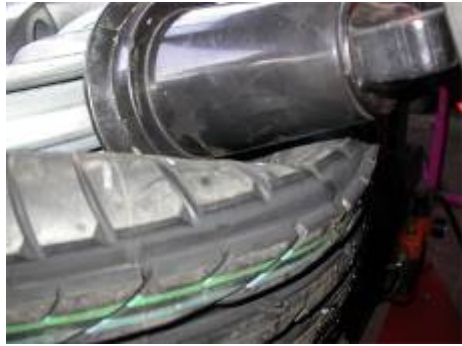
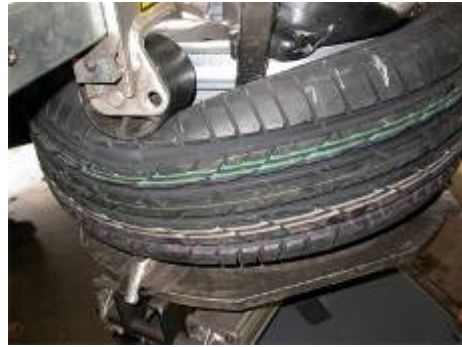
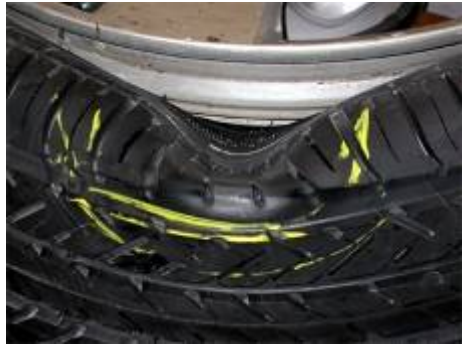
Characteristic : deformation / compression of belt edge during mounting procedure

Cause: unsuitable bead clamp

Consequence: discard tyre for risk of long-term damage caused by separation in belt edge area, poor uniformity causes vibrations and affects smoothness

Preventive measures: use bead clamps / hold-down devices; do not press too deep
